Hydrodynamic Bearing Damage and Remediation of Contributing Factors in Rotating Machinery

Blair B J^a and Pethybridge G^b

a Chief Engineer, Waukesha Bearing Corp, Pewaukee, WI, USA

Keywords: Hydrodynamic Bearings, Damage, Tilt Pad, Wiping

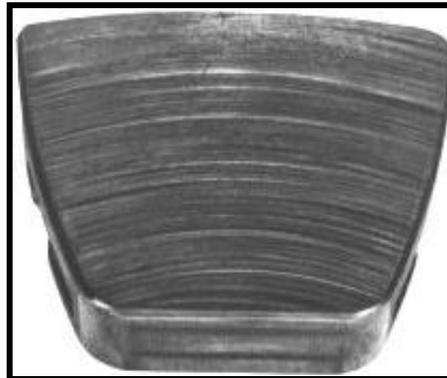
Fig 2. Abrasive Damage due to Foreign Material During Operation.

Ingestion of foreign matter or 'dirt' into turbomachinery bearings is a common source of damage to both thrust and journal bearings in all types of turbomachinery. Dirt may be present at start-up if the housings, shafts, lubrication path and bearing aren't properly prepared prior to assembling and starting the machine. Also, dirt may enter the bearing through the lubrication supply that has been contaminated from outside sources through breathers and air filters or from wear particles of other components during operation. The 'tracks' from abrasive particles at start-up when the speed is slow are irregular, and the particles may appear to have rolled through the bearing surface. Figure 1 is photograph of a thrust pad that was damaged by dirt during start-up. If the particles enter the bearing during operation when speeds are higher, the damage in the bearing surface is more likely to follow consistent patterns, such as concentric tracks in a thrust pad, as shown in Figure 2. Visual inspection and metallurgical study of the particle can be used to identify the source of the contamination, such as worn shaft material for example.

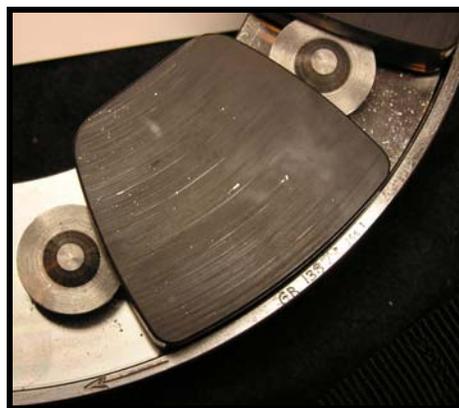
Fig 4. Polymer Lined Thrust Bearing with Showing Embedded Metallic Debris

One of the benefits of using a soft bearing material such as babbitt, also known as whitmetal, is its capability to embed material in the bearing surface. At the end of a particle track, the particle will embed itself in the babbitt, resulting in haloes or raised regions around the embedded particle, as shown in Figure 3. Polymer lined pads also have the capability to embed material. A polymer thrust bearing with metallic particles embedded into it is shown in Figure 4.

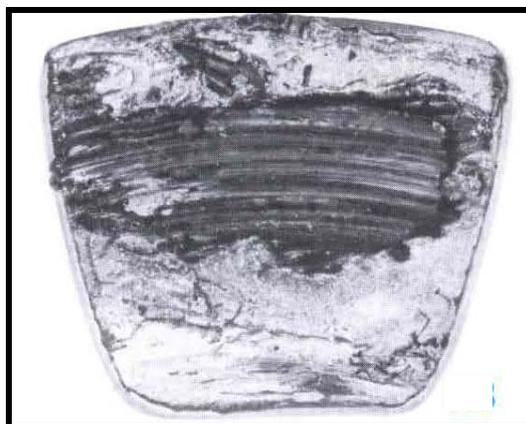
Fig 6. Black Scab on Thrust Pad.

One type of abrasive wear that causes severe damage to babbitt lined bearings and to shafts is 'wire wooling'. Wire wooling occurs when a relatively large particle is embedded in the babbitt. The particle may react with the shaft material and form a hard deposit, commonly known as 'black scab' on the pad. The hard deposit then causes severe damage to the mating surface by acting like a cutting tool; this machining then self-propagates to the point that the shaft and the bearing are inoperable. Figure 5 shows a shaft with wire wooling damage from a journal bearing. A thrust pad with 'black scab' damage is shown in Figure 6. Shafts and collars containing more than 1.3% chromium are susceptible to 'wire wooling' damage. Also, certain oil additive packages have been shown to increase the chances of wire wooling. Adding a low alloy steel sleeve to the shaft or chrome plating the shaft or collar will reduce the likelihood of wire wool damage to a steel with a significant amount of chromium (such as a stainless steel).

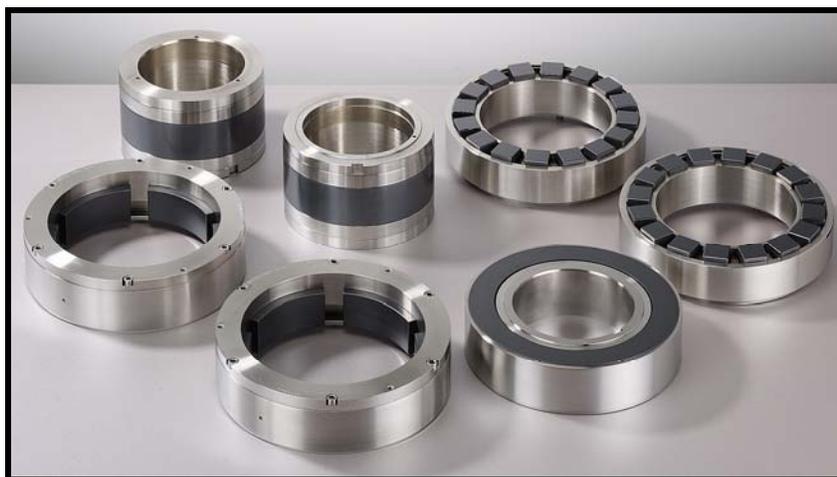
Fig 7. Ceramic Bearings from a Seawater Injection Pump.

Thoroughly cleaning the system prior to start-up and maintaining a clean lubricant supply is necessary to reduce the likelihood of damage from abrasives. If the amount of abrasive entering the bearing cannot be limited, for example in a process lubricated application, a ceramic bearing (commonly monolithic silicon carbide) can be used as a means to handle the abrasives. An example of a set of ceramic thrust and journal bearings for a water-injection pump is shown in Figure 7. The extremely hard material will 'grind' abrasives without any scoring of the bearing surfaces.

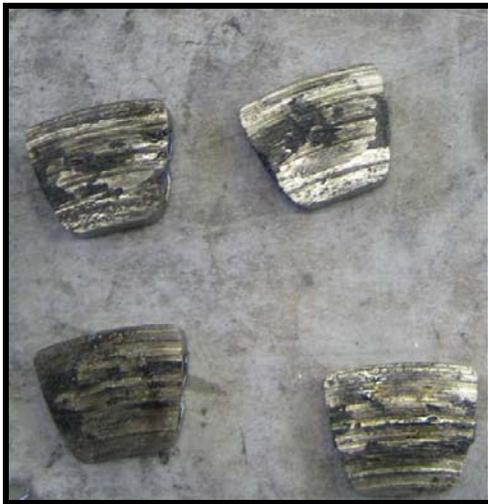
**Fig 8. Wiped Thrust Pad
Due to an Overload.**

Hydrodynamic bearings rely on a thin film of lubricant to separate the rotating shaft or collar from the stationary bearing. When the load exceeds the capability of the film to support the load, the rotating and stationary components contact each other. The contact leads to an increase in the temperature of the bearing lining that can lead to smearing or even localized melting of the bearing lining. Babbitt is selected as a bearing material because it is compatible (non-galling) with many metals and it has the capability to conform to the shaft, thus the babbitt wipes instead of seizing on the shaft. Light polishing or wiping of the babbitt surface indicates that the material has performed as needed. However, severe damage to the bearing will result if the overload is not reduced. A tilt pad thrust bearing that has been wiped due to an overload is shown Figure 8. Babbitt has been displaced from one area to another in the direction of rotation. Metallurgical analysis typically reveals a change in grain structure in the damaged layer from the base material.

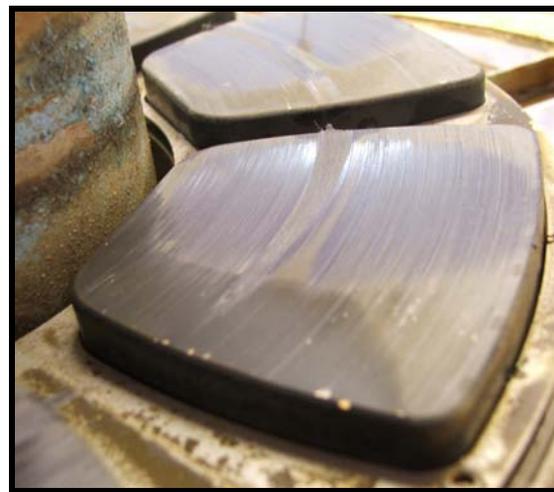
Fig 9. Worn Polymer Thrust Pad

Polymer bearings, like babbitt lined bearings, have good bearing properties but can also be overloaded and wear due to the contact between the bearing and the journal or collar. Figure 9 shows a thrust pad that has been lightly overloaded resulting in melting of the polymer and the characteristic formation of a fibrous ball of wiped material on the trailing edge.

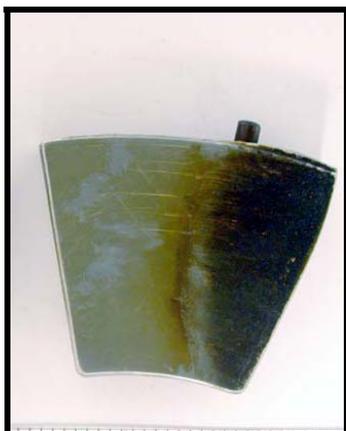
Fig 10. Coking on Thrust Pad Due to Excessive Temperature.

As the lubricating fluid passes through the bearing clearance it undergoes shearing, which generates heat. This heat is mostly carried away by the lubricant but some is also transferred to the bearing. Operating bearings at excessive temperatures continues to be a common cause of damage to bearings. The high temperatures can be generated by different mechanisms, such as high loads, high inlet temperatures, high speed, and insufficient lubrication. Excessive temperatures are sometimes indicated by a blackened (oil coking) area on the pad, as shown in Figure 10.

The yield strength of babbitt falls off rapidly with increasing temperature, which can lead to creep when the actual, local pressure exceeds the yield strength of the babbitt at the local temperature. The bearing surface has a rippled appearance, as shown in Figure 13, due to the babbitt flowing under the high pressure and temperature. Potentially, the babbitt can continue to flow past the edge of the pad, as also shown in Figure 10. Note that wiping hasn't necessarily occurred because there hasn't been bearing to shaft contact.

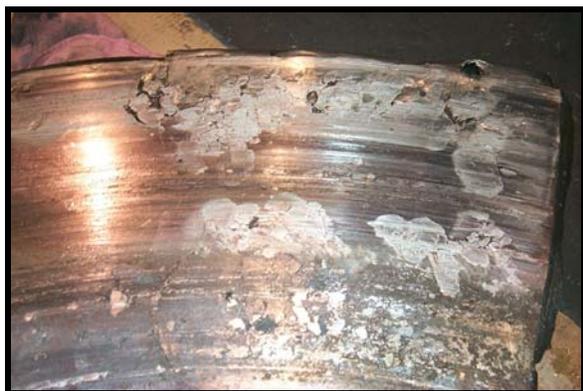
Fig 12. Intergranular Cracking on a Thrust Pad From Excessive Temperatures.

Babbitt is an anisotropic material with different thermal expansion coefficients along different grain axes. Thermal cycles through large temperature ranges may lead to a mottled (faceted) appearance of the bearing surface or, if excessive, intergranular cracking of the babbitt due to the anisotropic nature of babbitt. Typically, faceting, as shown in Figure 11, is not detrimental but highlights the different grains in the babbitt structure. However, high temperature gradients can lead to intergranular cracking. Shear and normal forces act on the babbitt, potentially opening up cracks. A thrust pad with intergranular cracking is shown in Figure 12.

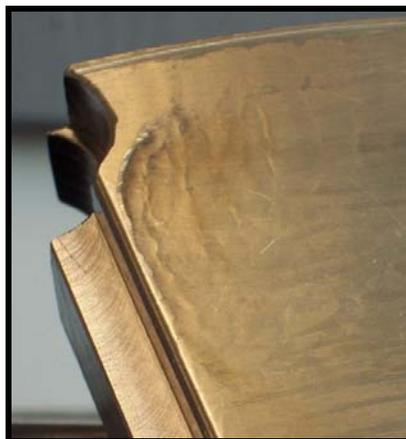
Fig 13. Thrust Pad with Rippled Surface From Creep.

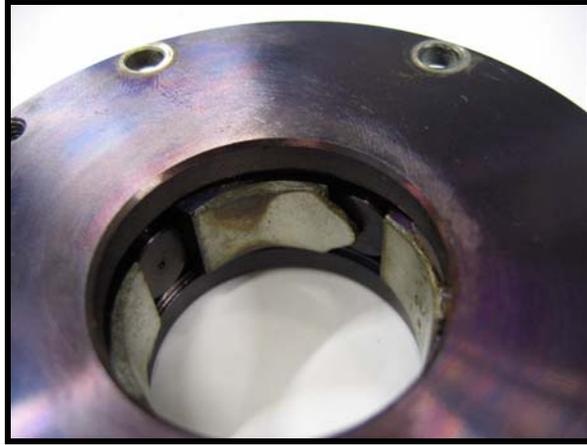
Fig 14. Tilt Pad Journal Bearing Damaged by Heat Soak Back.

Another source of potential damage to turbine bearings, in particular, is latent heat in the shaft or housing conducting into the tilt pads once the rotor has stopped. Often referred to as 'heat soak back', the heat from the shaft or housing may be sufficient to melt the babbitt if cooling lubrication is not maintained. Figure 14 shows journal tilt pads where the babbitt melted due to heat soaking from the machine casing into the bearing. When cooling lubrication cannot be guaranteed, the babbitt can be replaced with a material that can withstand the higher temperatures but also has good bearing characteristics. Engineered polymers can be used as alternate to babbitt to combat potential damage due to heat soak back. A polymer lined tilt pad journal bearing is shown in Figure 15.

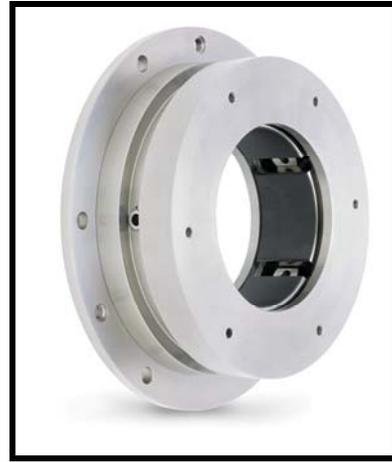
Fig 15. Polymer Lined Tilt Pad Journal Bearing.

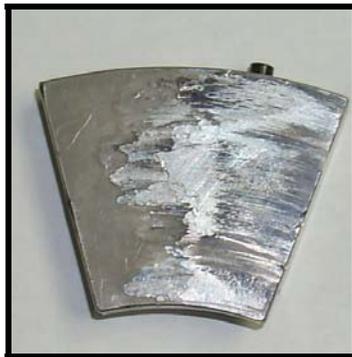
Fig 16. Wiping of a Tilt Pad Thrust Bearing Due to Loss of Lubrication.

Hydrodynamic bearings, including tilt pad journal and tilt pad thrust bearings, rely on a film lubricant to separate the rotating and stationary components. Typically, mineral or synthetic oil is used as the lubricant in turbomachinery. Increasingly, process fluids, such as water, toluene, and refrigerant, are also being used as the bearing lubricant. In addition to providing the necessary fluid to form the film, the lubricant is also used to carry heat away from the bearing. When the lubricant is interrupted, either momentarily or for an extended period time, the hydrodynamic film does not form and is insufficient to support the load; contact between the rotating and stationary parts can occur. Even if contact doesn't occur due to inadequate lubrication, the cooling effect will be incomplete, resulting in overheating of the bearing material. A damaged thrust pad and journal bearing from inadequate lubrication is shown in Figure 16 and 17, respectively.

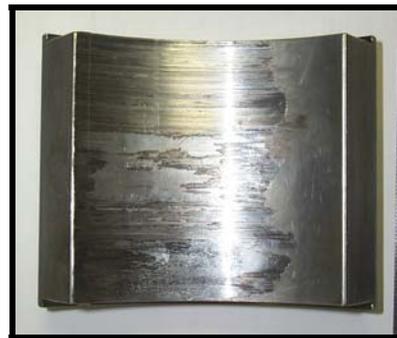
Fig 17. Light Wiping of a Journal Tilt Pad Due to a Momentary Reduction in Oil Flow.

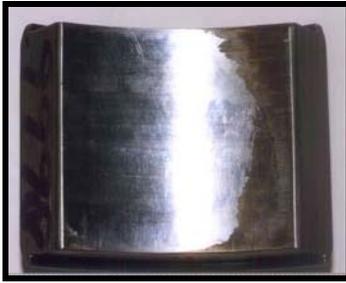
Fig 18. Light Wiping of a Journal Tilt Pad Due to a Momentary Reduction in Oil Flow.

The damage to the bearing surfaces often resembles the damage that results from overload. The surfaces can be wiped and the babbitt being smeared. The bearing surfaces may have the appearance of being overheated with oil varnish appearing on the surfaces. An interesting form of wiping has been observed when the oil was momentarily interrupted due to a reduction in flow from a pump that momentarily loses pumping capacity, which may have occurred from a reduction in power to the pump. The babbitt on the pad surfaces reached a temperature sufficient to melt but quickly re-solidifies, forming a thin foil of babbitt on the pads. Figure 18 shows a tilt pad journal bearing that was damaged by a momentary interruption in oil flow to the bearing. During investigation into the damaged pads, a thin foil (shown in Figure 19) of babbitt was removed from the journal pad. The damage to this pad was attributed to an occasional decrease in the lubricant flow from the main lubrication pump due to a drop in electrical power to the pump motor.

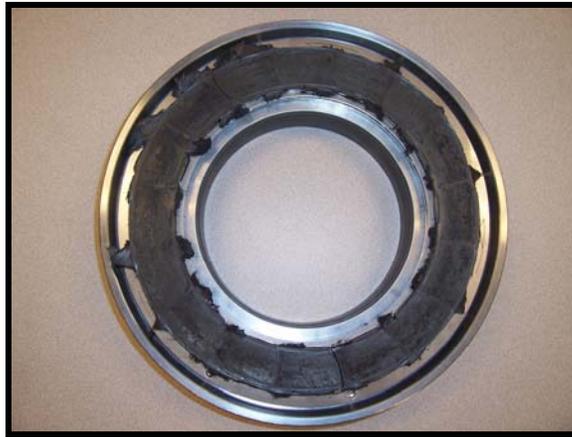
Fig 20. Damaged Polymer Thrust Bearing Due to Insufficient Lubrication.

Materials with solid particle lubrication can be used to combat inadequate lubrication. Polymer bearings have the ability to operate with reduced lubrication that occur during a brown out or coast-down under load, but will have excessive wear if allowed to operate continuously without lubrication under typical turbomachinery conditions. Figure 20 shows the damage to polymer tilt pad thrust bearing when the lubrication was interrupted. Obviously, the best prevention is a system that maintains adequate lubrication to the bearing at all times.

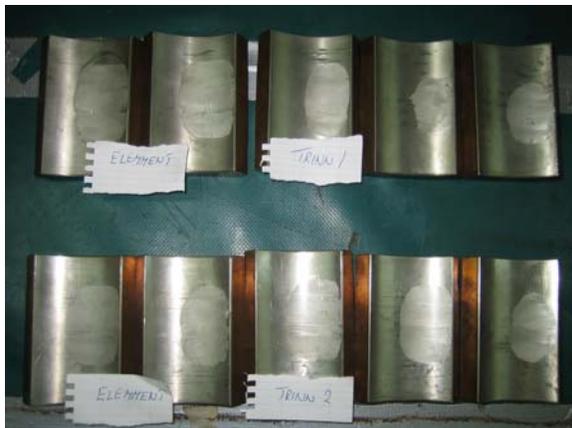
Fig 21. Wiping of All Journal Tilt Pads Due to Loss of Clearance at Start-up.

The clearance between the bearing bore and shaft in tilt pad journal bearings is often designed to be 'tight' in order to achieve specific bearing performance. During quick starts on cold machines, such as gas compressors driven by motors, a 'tight' bearing clearance may be lost as the shaft and pads thermally expand quickly while the bearing housing and machine casing do not. The shearing of the lubricant in the film is the heat source for the thermal growth. But, the housing and casing don't expand as fast as the pads and shaft because of their relatively large thermal mass and the poor conduction of heat from the pads to the housing. With the shaft expanding due to the heat and the pads growing inward from the thermal growth but being restricted by the housing, the clearance between the pads and the shaft is reduced, causing a transient loss in clearance. With the clearance reduced, all of the pads contact the shaft, resulting in wiping of all the pads around the bearing. If the loss of clearance is severe enough, the rotor may seize. A set of journal tilt pads are shown in Figure 21 with all of the pads wiped over the pivots. This type of damage occurs during start up and isn't necessarily accompanied by dynamic vibrations. The machine's operational data should be reviewed to confirm that the damage didn't originate from high dynamic loads and orbits, as shown in Figure 22.

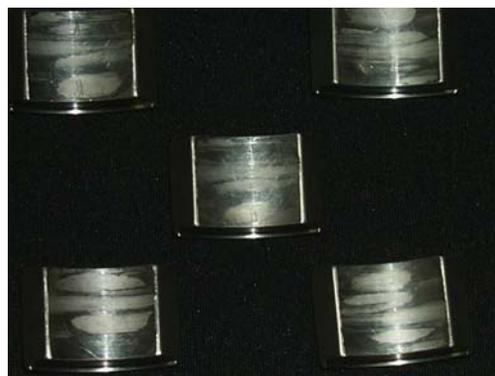
Fig 22. High Dynamic Load Damage to All Tilt Journal Tilt Pads.

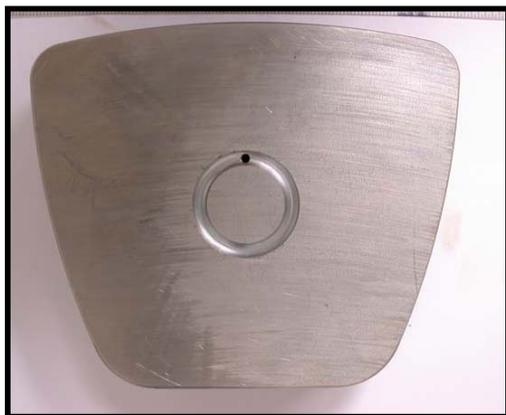
Fig 26. Thrust Tilt Pad with Electrical Discharge Damage.

During operation, electrical charge may build up on the shaft. Sources of this 'charge' can be from residual magnetic fields on the shaft, varying electrical-mechanical fields, stray shaft currents or static electricity build up from 'wet' stages on a steam turbine. When the electrical potential is sufficient, the charge will arc to ground through the path of least electrical resistance. Because fluid film bearings operate on very thin films of lubricant, the arc often passes from the shaft to ground through the bearing if the bearing is unprotected. When the charge does jump the gap between the stationary bearing and the rotor, the babbitt material is 'spark' eroded by the arc. The resulting pits are typically hemispherical and shiny, giving a frosted appearance to the damaged area. There are typically no high spots around the pits, as may occur with embedded particles (haloes). Often the damage starts at an area of minimum film and then increases in size as material is removed, resulting in a clear boundary between the area of the pad with the damage and the area without. If the electrical arcing continues, the majority of the pad can be spark eroded and the backing material can be exposed. Typically, the rotating part also has similar pitting. Figures 26 and 27 show thrust pads that have been damaged by electrical discharge. Note the distinct transition 'line' from undamaged to frosted area on the thrust pad. A portion of the damage area of the pad in Figure 26 is shown at a higher magnification in Figure 28. Figure 29 is a microphotograph of one of the electric discharge pits. Damaged pads should be repaired or replaced. The shaft or collar should also be repaired to remove any defects.

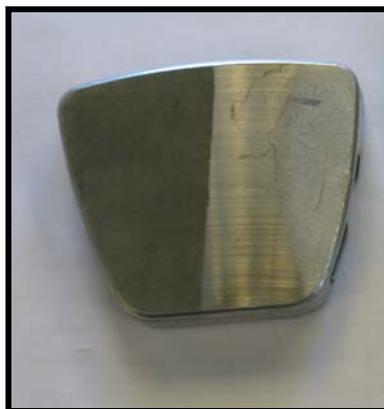
Fig 27. Thrust Tilt Pad with Electrical Discharge Damage.

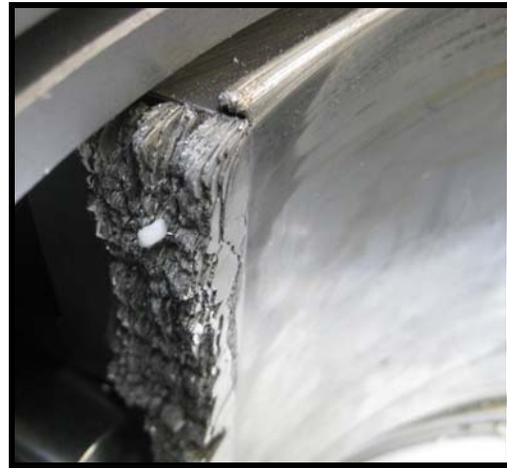
**Fig 35. Wiping of a Journal Tilt Pad
Due to High Loads at Start-up.**

Prior to reaching a speed that is sufficient to develop a hydrodynamic film, the stationary and rotating components of the bearing are in metal-to-metal contact, initially without any lubrication between the surfaces (boundary lubrication) and then with marginal lubrication between the surfaces (mixed lubrication). The contact between the surfaces causes polishing of the bearing material and eventually may result in the wearing of the bearing material. With the removal of the material the bearing no longer performs as designed. Many types of turbomachinery can have high loads at start-up. Tilt pad journal bearings on large gas and steam turbines are often subjected to high loads (the weight of the rotor) at start-up. Thrust bearings in vertical pumps and hydroturbines often have to support the weight of the shaft, motor and impellers. Another example of a machine with high start-up load is an overhung gas compressor, where pipeline pressure may place a high load at start-up on the normally unloaded thrust bearing. Figures 34 and 35 show thrust and journal tilt pads that have been damaged due to excessive load at start-up and during shut down. Note the thin layers of babbitt that build up on the edge of the pads due to successive starts and stops under excessive load.

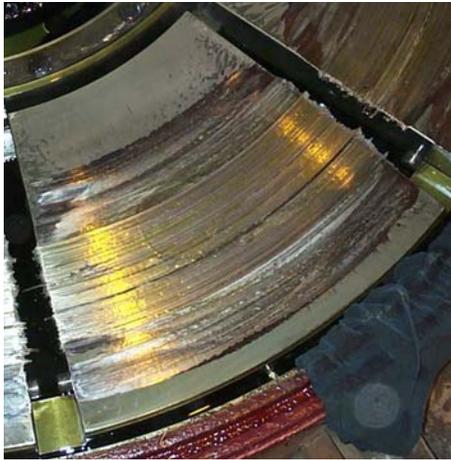
Fig 36. Damaged Thrust Tilt Pad with a Hydrostatic Lift Pocket; Hydrostatic System Failed.

To eliminate the chances of damaging the bearing at start-up or during operation at low speeds and high loads, hydrostatic lift (jacking oil) systems are employed. High pressure oil that is supplied by an external pump is injected into a pocket in the pad that is specifically designed to lift (jack) the shaft away from the bearing. In addition to protecting the bearing at start-up from damage, hydrostatic lift pressure also reduces the start-up torque to allow for the rotor to turn over easily. A low start-up torque is often necessary for motor driven machinery to start. Also, a large gas turbine can be turned by a short lever and hand with a lift system. Not only does the system need to operate at start-up but also at shut down if the high load is present as the machine comes to a stop. A damage thrust pad is shown in Figure 36. The vertical motor was brought down without the hydrostatic lift pressure being supplied. Bearings made with advanced materials also can be damaged during start-up and shut down while under load. 'Scuffed' ceramic thrust pad surfaces from a pump are shown in Figure 36. During start-up and shutdown the ceramic bearing acted as a disc brake in the pump.
