Case Study: Optimized Bearings and Dampers Provide Long-term Solution to Vibrations

PROJECT OVERVIEW

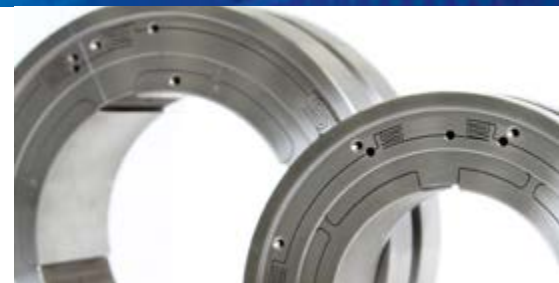
Figure 3: Damage on the OEM bearing outer diameter from bottoming out

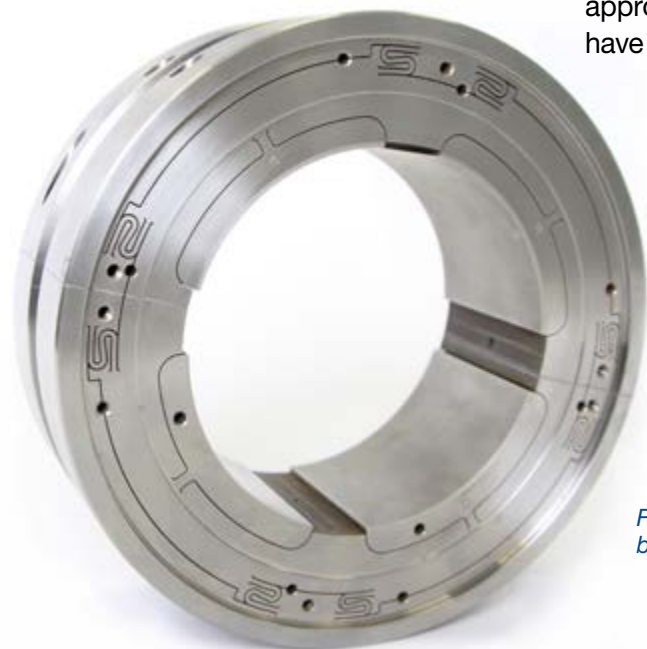
Figure 1: Flexure Pivot tilt pad journal bearing with ISFD technology

In 2013 the compressors were placed back in service with the optimized bearings and dampers (Figure 1). Since then the compressors have exhibited low vibration levels that do not grow over time. They have had no trips and have not required field balancing for continuous operation. Overall efficiency has increased by approximately 1% and site profits have improved.

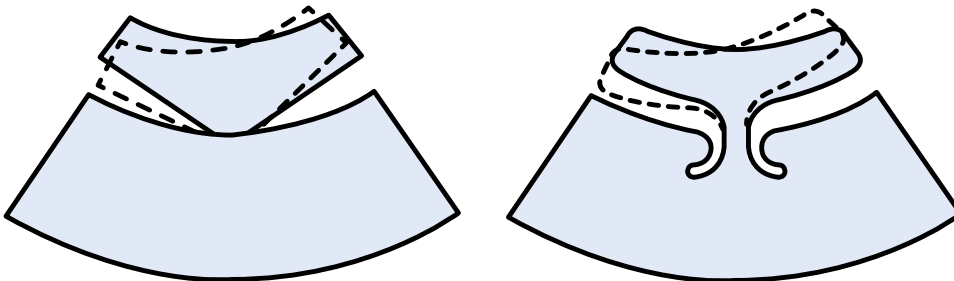
Figure 4: Conventional contact point tilt pad (left) and Flexure Pivot tilt pad (right)

To address the pivot wear, Bearings Plus applied its proprietary Flexure Pivot TPJ bearing. The Flexure Pivot design has a pad and pivot that is integral to the bearing shell, eliminating metal-to-metal

contact between the pad and shell when the pad tilts (Figure 4). The bearing manufacturing method, electrical discharge machining (EDM), provides tight control of the clearance and preload for bearing optimization. By eliminating pivot wear, the Flexure Pivot TPJ bearing permanently maintains the original bearing clearance and original preload, changes in which can contribute to vibrations.

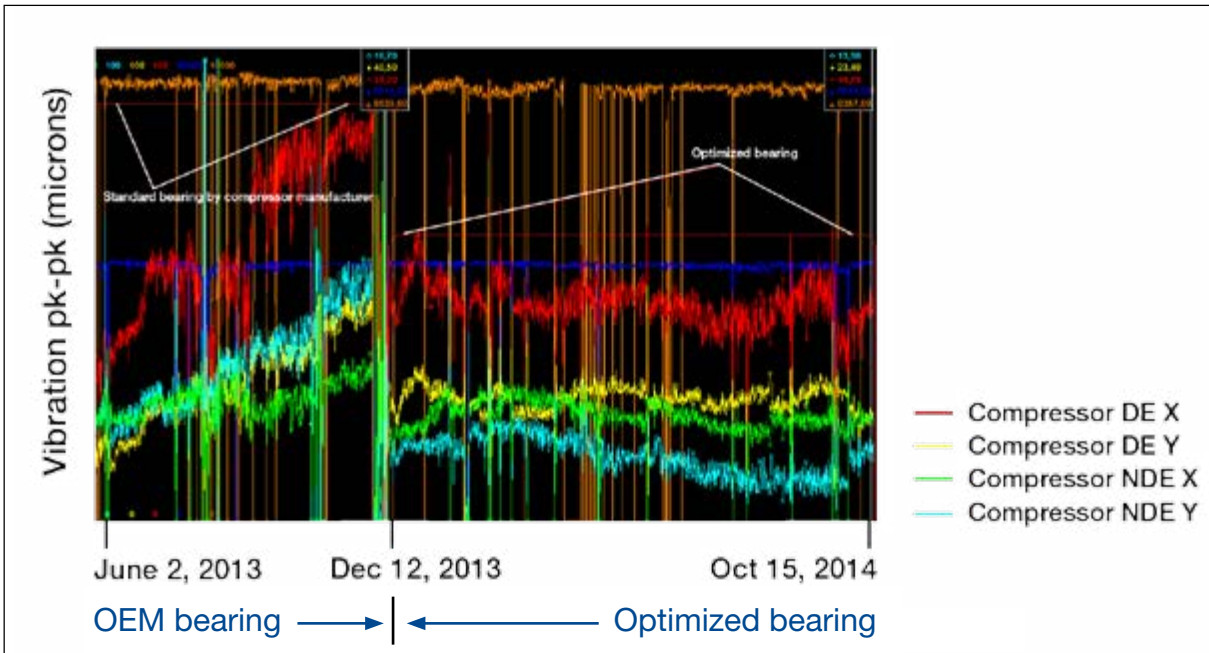
Figure 5: Compressor vibration trend with an OEM bearing over a six-month span followed by the upgraded bearing over a 10-month span.

The three upgraded compressors all showed significant improvement with the optimized bearings and dampers. Compressor A vibrations dropped by more than half, Compressor B vibrations

dropped from 90 μm to less than 50 μm (Figure 5), and Compressor C vibrations dropped to less than 30 μm with the upgrade. The compressors have maintained the low vibration level over time (Figure 6). In addition, the optimized Flexure Pivot TPJ bearings with ISFD technology have eliminated the small subsynchronous vibrations experienced with the O-ring damper.

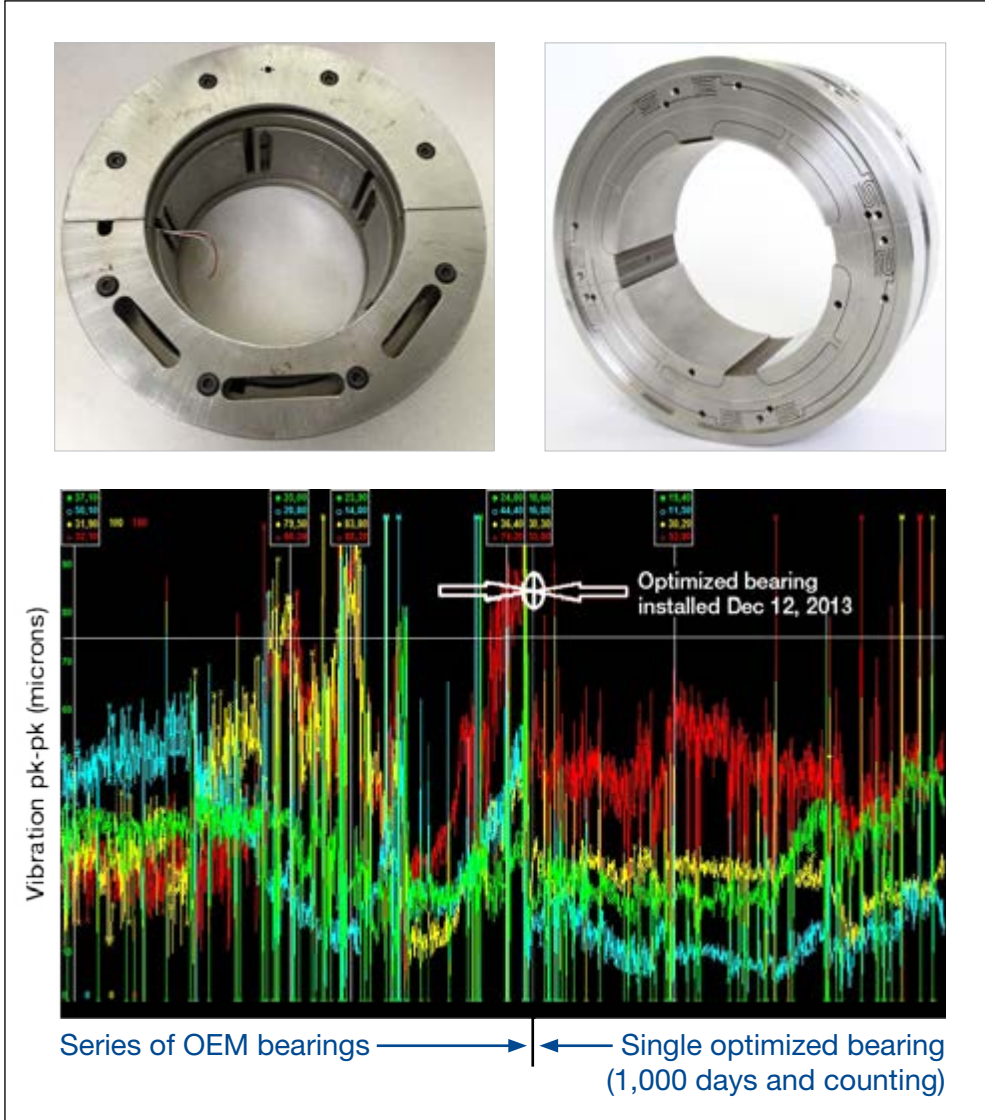
Figure 6: Compressor vibration trend with a series of OEM bearings (top left) over approximately 1,000 days followed by performance of an optimized bearing (top right) over a similar period. Vibration with the optimized bearing has remained steady with no problems and no bearing replacements.
