Case Study: Optimized Bearings and Dampers Provide Long-term Solution to Vibrations

PROJECT OVERVIEW

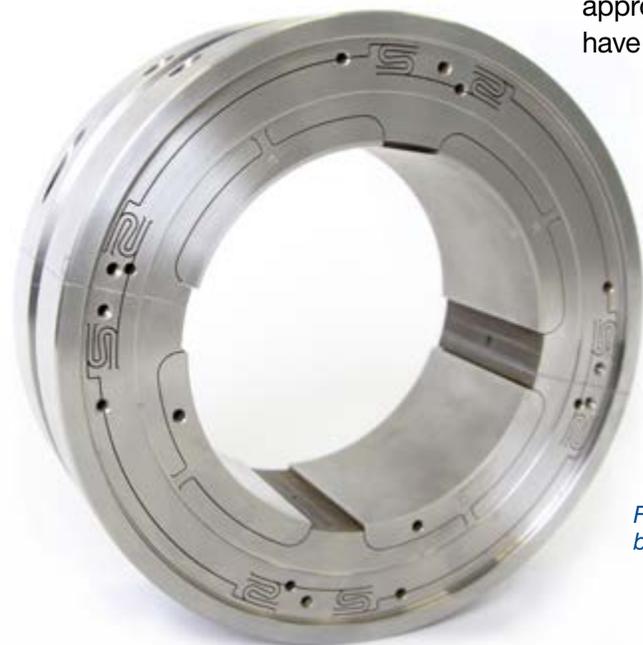
Figure 1: Flexure Pivot tilt pad journal bearing with ISFD technology

In 2013 the compressors were placed back in service with the optimized bearings and dampers (Figure 1). Since then the compressors have exhibited low vibration levels that do not grow over time. They have had no trips and have not required field balancing for continuous operation. Overall efficiency has increased by approximately 1% and site profits have improved.

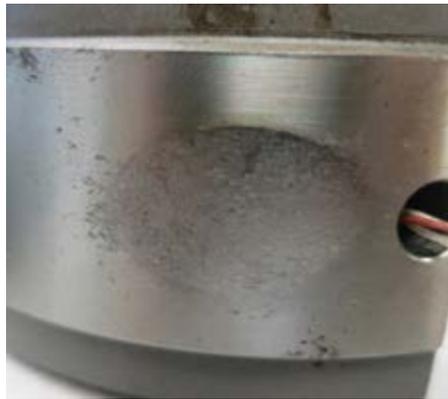
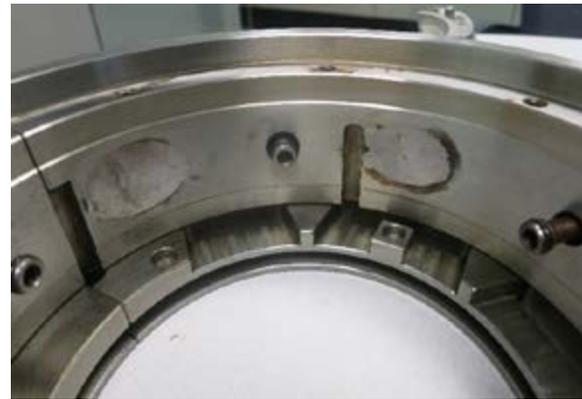
Inspection of the removed OEM bearings showed severe pivot wear on the tilt pads and bearing shell bore (Figure 2). This wear increased the bearing clearance by 63 microns or more in a five-month period, causing alarming vibrations. The inability of the O-rings to provide centering capability under static deflection, together with the increased vibrations, resulted in bearings bottoming out in the casing (Figure 3) and loss of squeeze film damper performance. These factors converged to increase vibrations over time in the LP casings of the compressors.

Figure 2: Pivot wear on the point-contact-pivot tilt pad (left) and bearing shell bore (right)

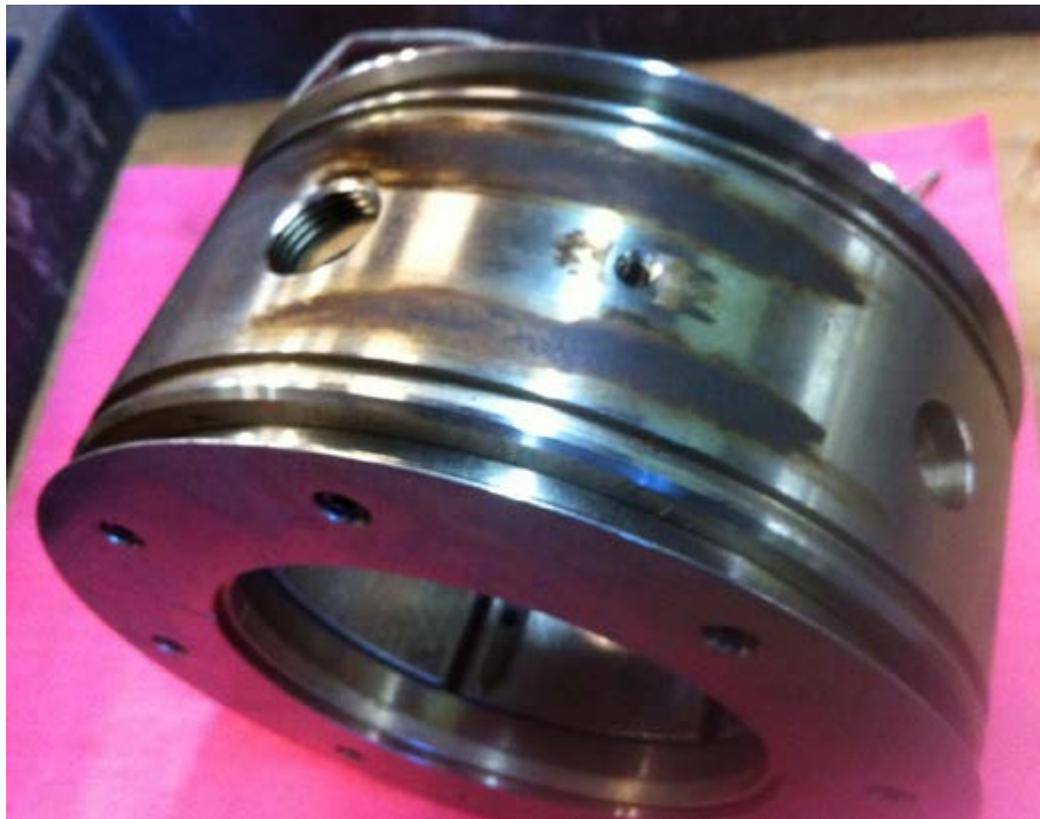
Figure 3: Damage on the OEM bearing outer diameter from bottoming out

The second part of the solution was the use of patented ISFD technology in place of the O-ring squeeze film damper. Like the Flexure Pivot tilt pad, the ISFD design is manufactured by EDM as part of the bearing itself, not a separate piece. The design offers many benefits over an O-ring damper, including accurate stiffness control, optimized damping, and the ability to center the rotor under static load. Moreover, ISFD technology eliminates changes in stiffness and damping over time. The integral squeeze film damper will not experience degradation or cause the bearing to bottom out, as O-rings can.

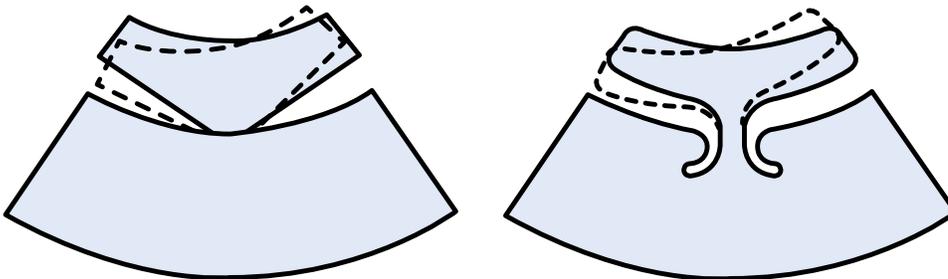
To address the pivot wear, Bearings Plus applied its proprietary Flexure Pivot TPJ bearing. The Flexure Pivot design has a pad and pivot that is integral to the bearing shell, eliminating metal-to-metal

contact between the pad and shell when the pad tilts (Figure 4). The bearing manufacturing method, electrical discharge machining (EDM), provides tight control of the clearance and preload for bearing optimization. By eliminating pivot wear, the Flexure Pivot TPJ bearing permanently maintains the original bearing clearance and original preload, changes in which can contribute to vibrations.

Figure 4: Conventional contact point tilt pad (left) and Flexure Pivot tilt pad (right)

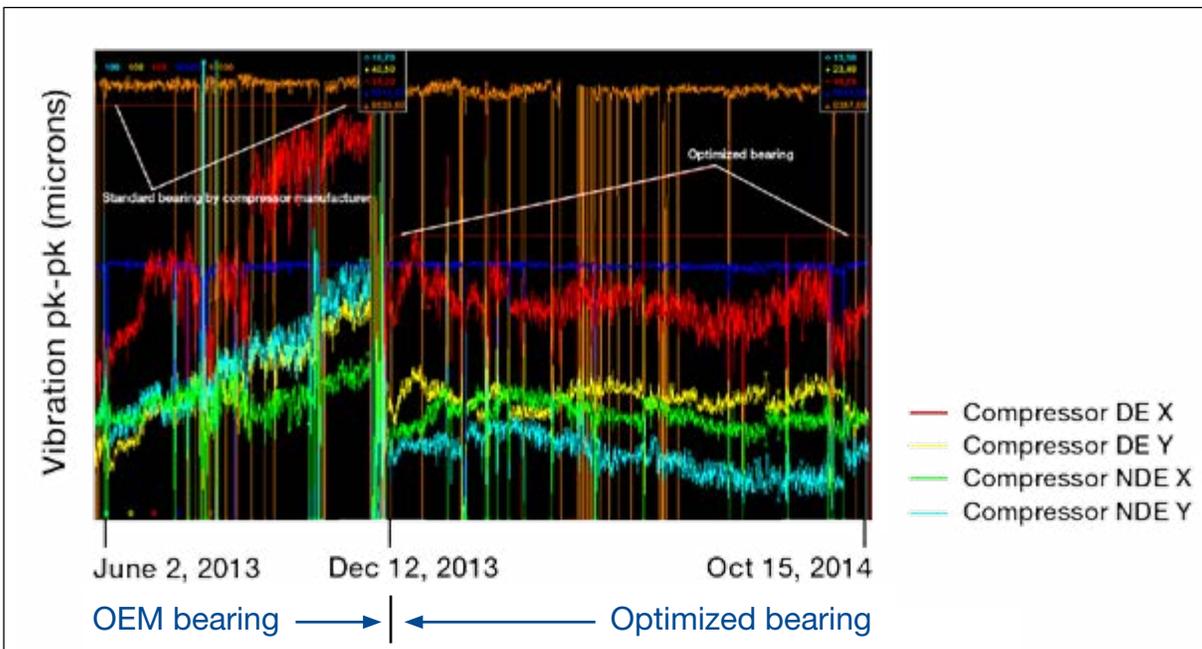
The three upgraded compressors all showed significant improvement with the optimized bearings and dampers. Compressor A vibrations dropped by more than half, Compressor B vibrations

dropped from 90 μm to less than 50 μm (Figure 5), and Compressor C vibrations dropped to less than 30 μm with the upgrade. The compressors have maintained the low vibration level over time (Figure 6). In addition, the optimized Flexure Pivot TPJ bearings with ISFD technology have eliminated the small subsynchronous vibrations experienced with the O-ring damper.

Figure 5: Compressor vibration trend with an OEM bearing over a six-month span followed by the upgraded bearing over a 10-month span.

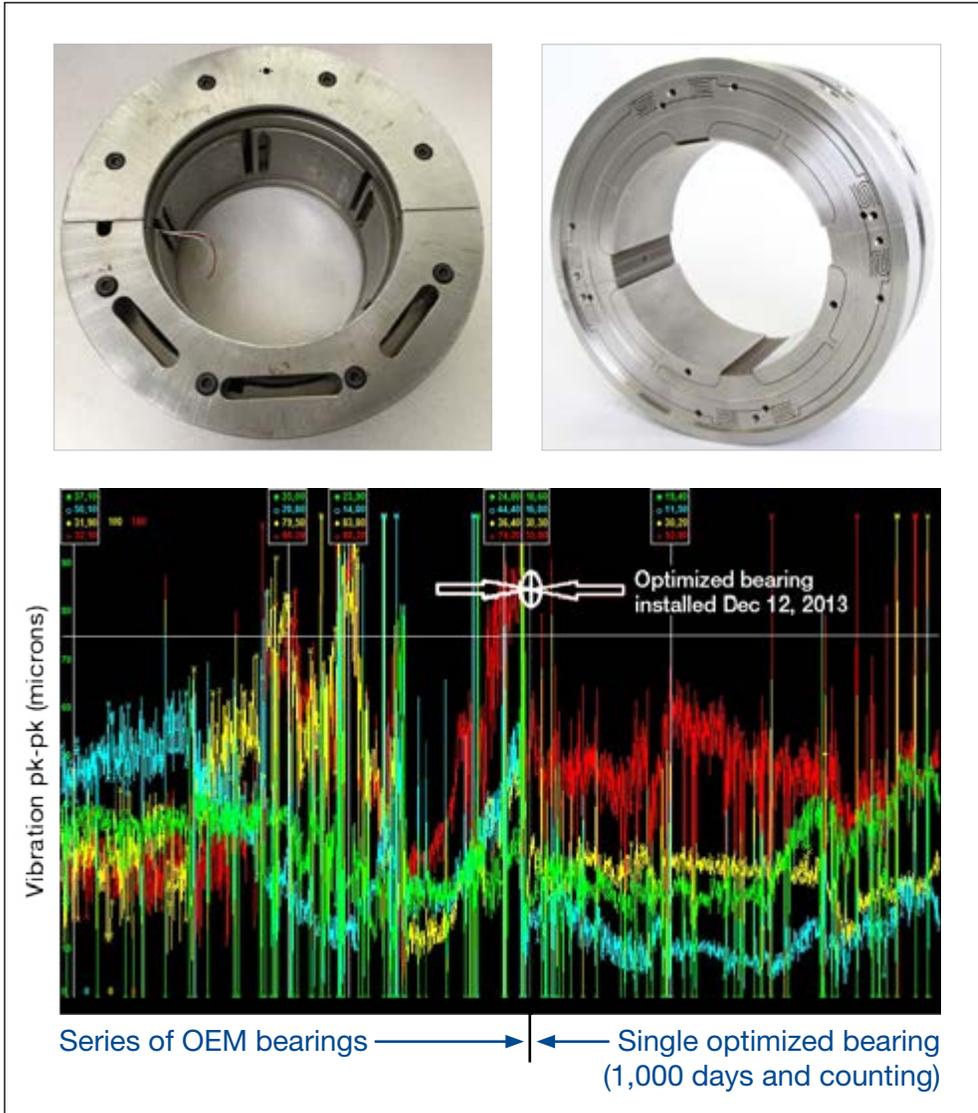
Figure 6: Compressor vibration trend with a series of OEM bearings (top left) over approximately 1,000 days followed by performance of an optimized bearing (top right) over a similar period. Vibration with the optimized bearing has remained steady with no problems and no bearing replacements.
